Methods of removing fractured instruments from root canals — brief case reports and review of literature

¹ Department of Conservative Dentistry and Endodontics, Poznan University of Medical Sciences, Poland

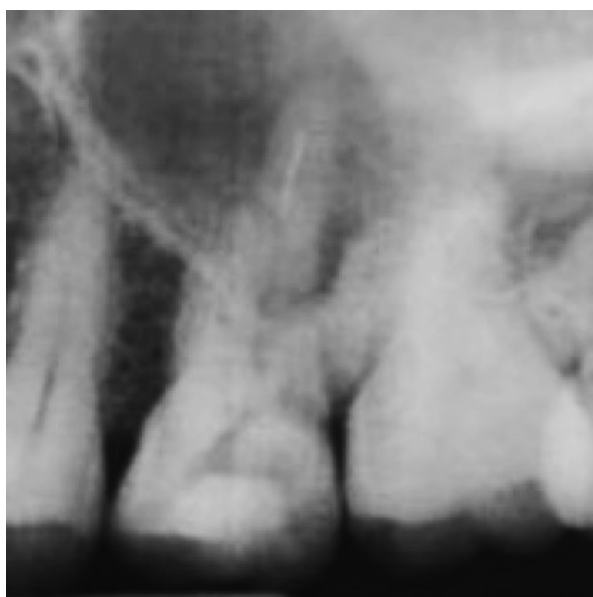
Figure 3. Preoperative radiograph of the tooth 16 — fractured instrument fragment visible in the palatal root

graphs revealed that the fractured instrument was located approximately 3 mm from the radiographical apex of the palatal root canal (**Figure 3**). Attempts were made to remove the fractured instrument fragment. At the beginning the orifice of the root canal was widely prepared using Gates-Glidden burs #4 and #5. The fractured instrument frag-

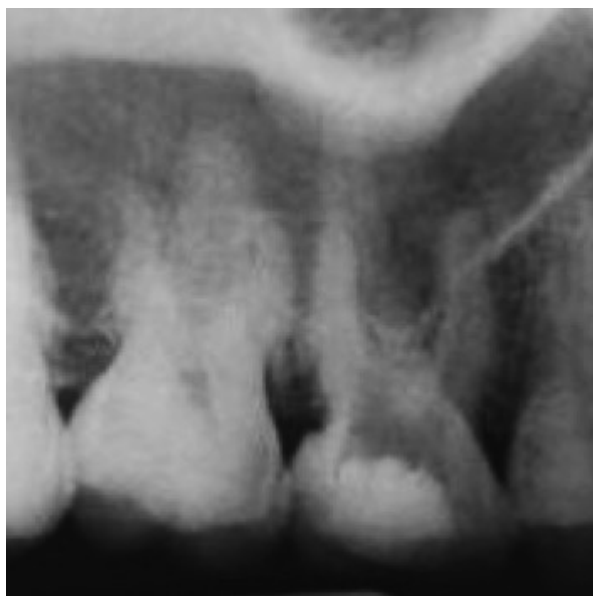
Figure 4. Radiograph of the tooth 16 after successful removal of the fractured instrument fragment from the palatal root canal

ment was then visualised under operating microscope. Dentin surrounding the fractured fragment was removed up to the depth of 2mm with the use of ultrasonic Endo-chuck tool with SS K-file mounted on it, thanks to which a slight mobility of the tool was achieved. During the procedure the canal was irrigated with 2% sodium hypochlorite. Injection needle (size 6) with aspirated dual cement (Elite Maxcem, Kerr) was then placed on the exposed end of the fractured instrument. After the cement had begun to set, the needle was carefully removed with the instrument in it. The removal of the instrument was confirmed with a control radiograph (**Figure 4**). Root canals were then finally prepared chemomechanically and obturated with gutta-percha and AH-Plus sealer using lateral condensation technique.
